# Walk Around

## Focke-Wulf Fw 190A/F

Walk Around Number 22  
squadron/signal publications

By Malcolm Laing and E. Brown Ryle

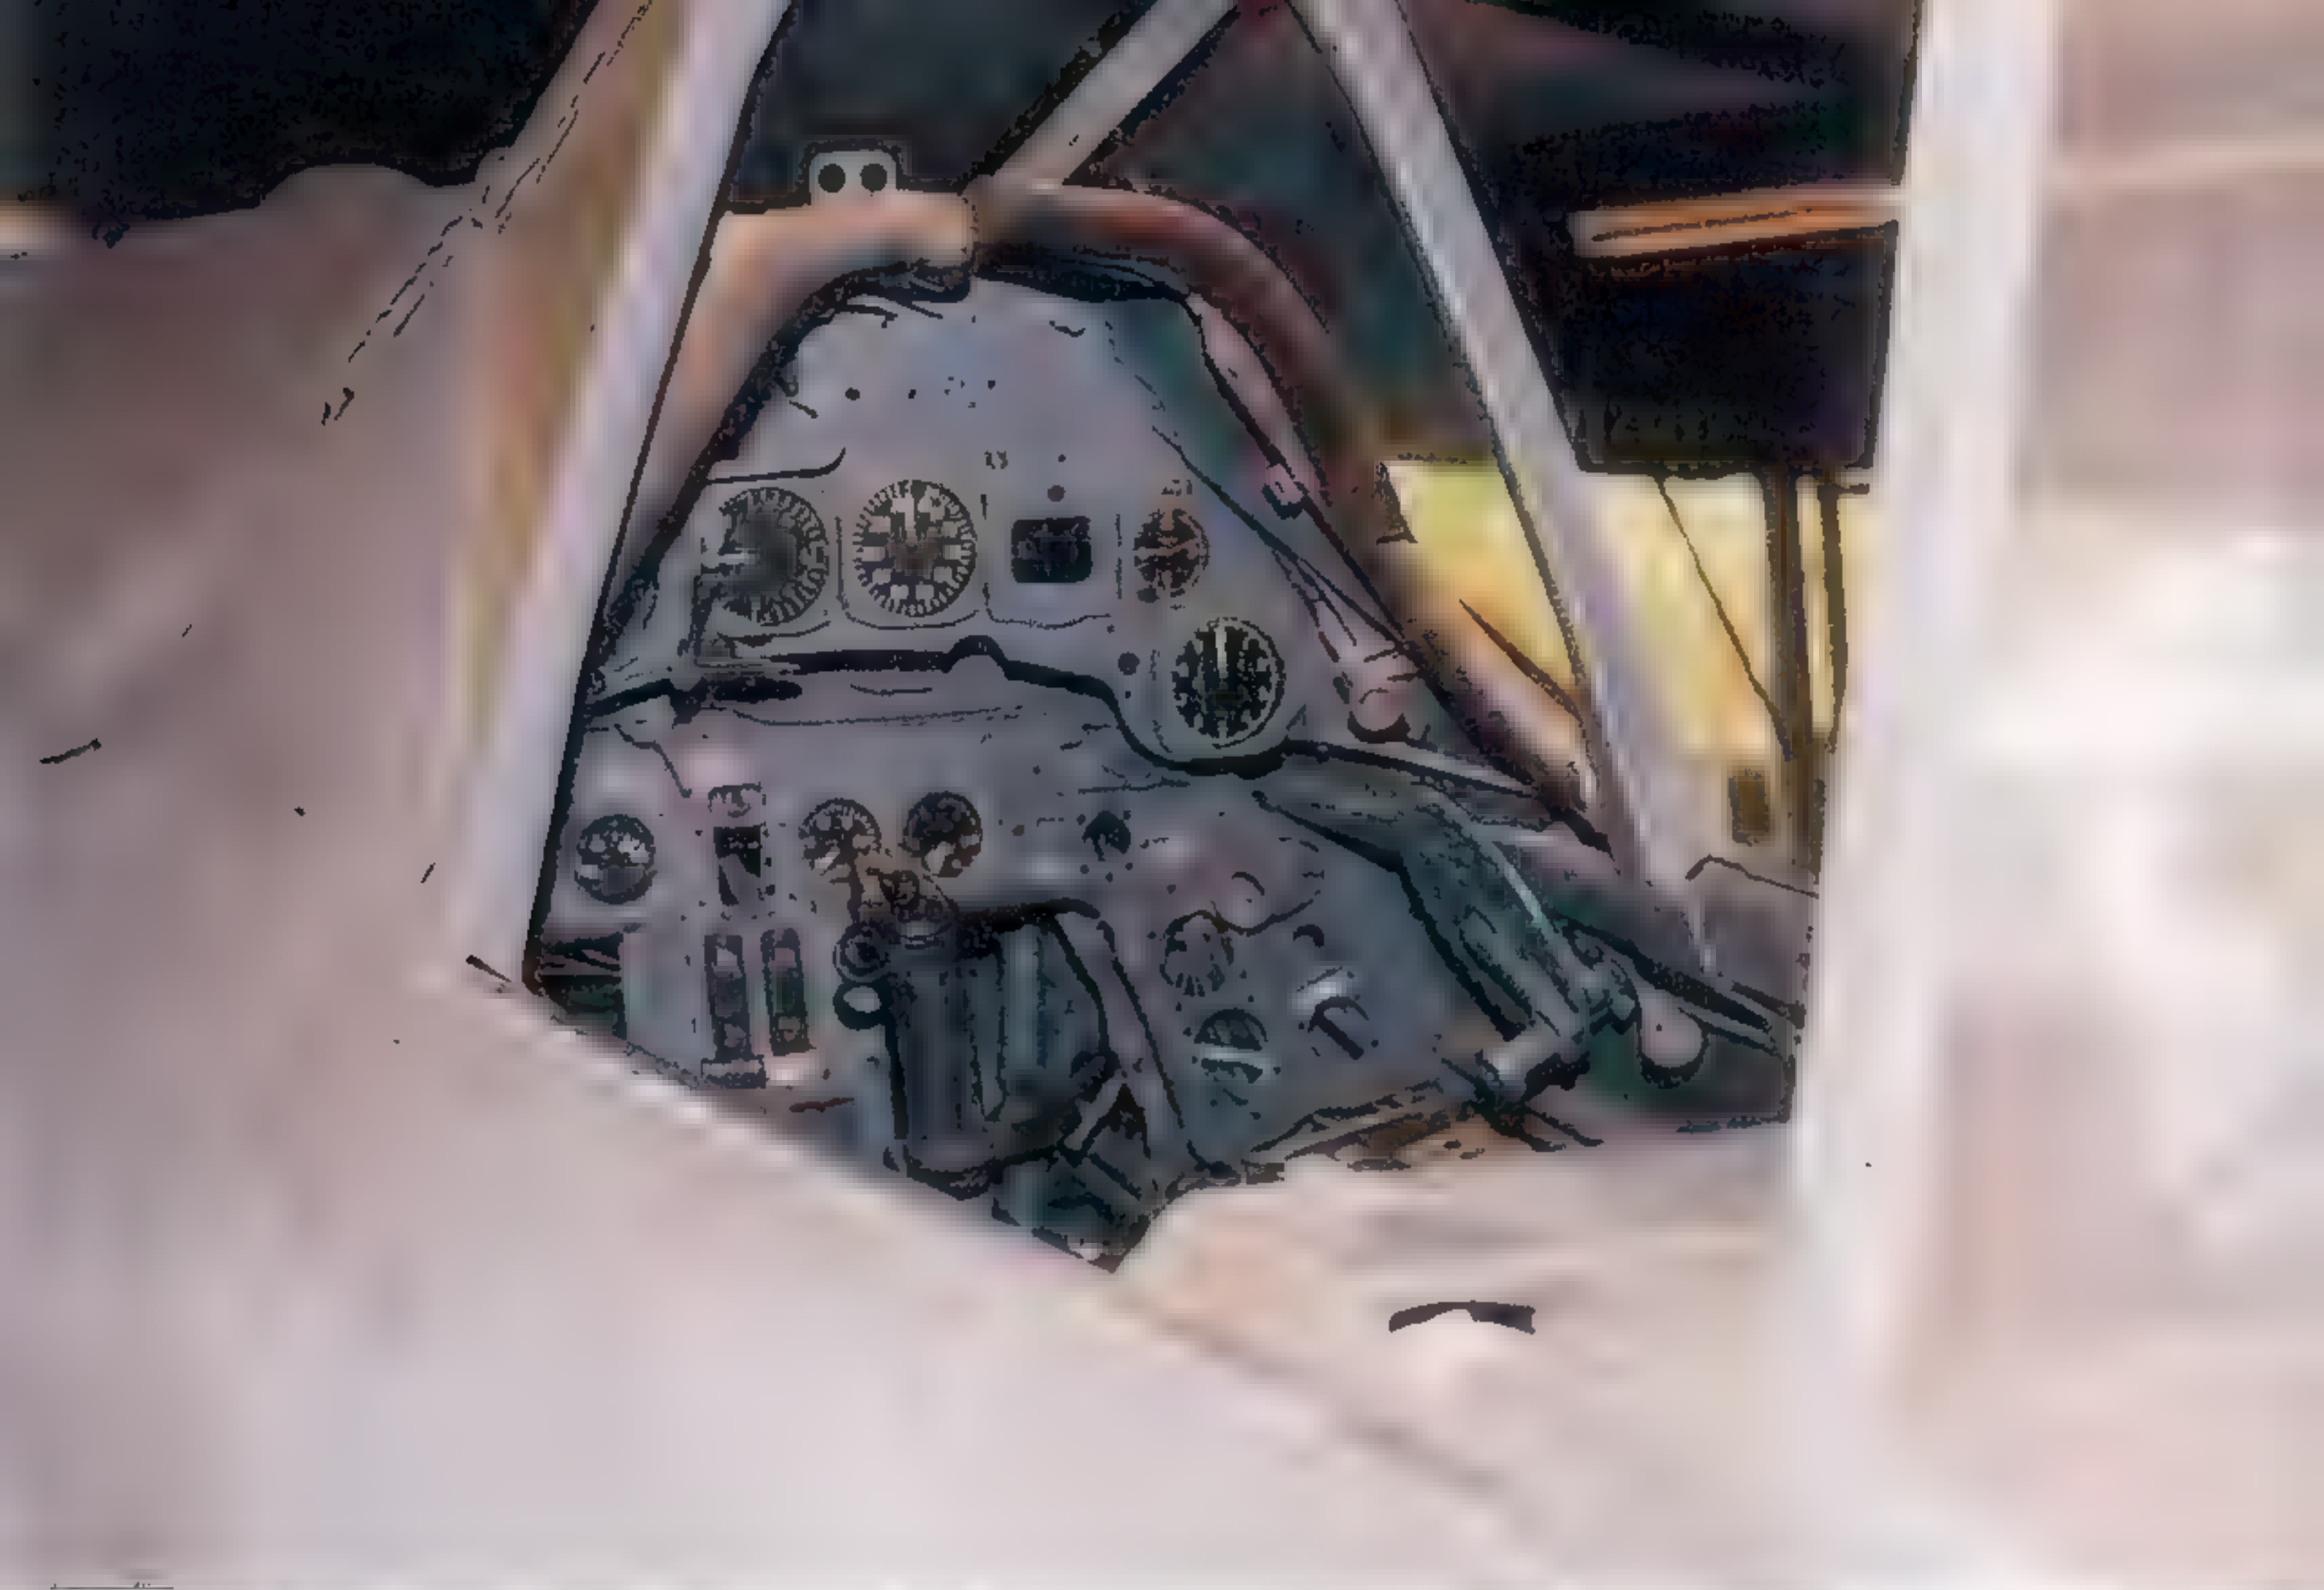
The Fw 190A-6 canopy crank is located on the starboard side of the cockpit, immediately aft of the instrument panel. The early 'spoon handle' canopy jettison lever is adjacent to the crank. The canopy is opened by first pulling out and turning the lever, then the crank is turned clockwise until the last tooth of the canopy drive unit is reached. A rarely seen second air vent is installed on the right side ahead of the canopy crank. (Molnar & Hugo)

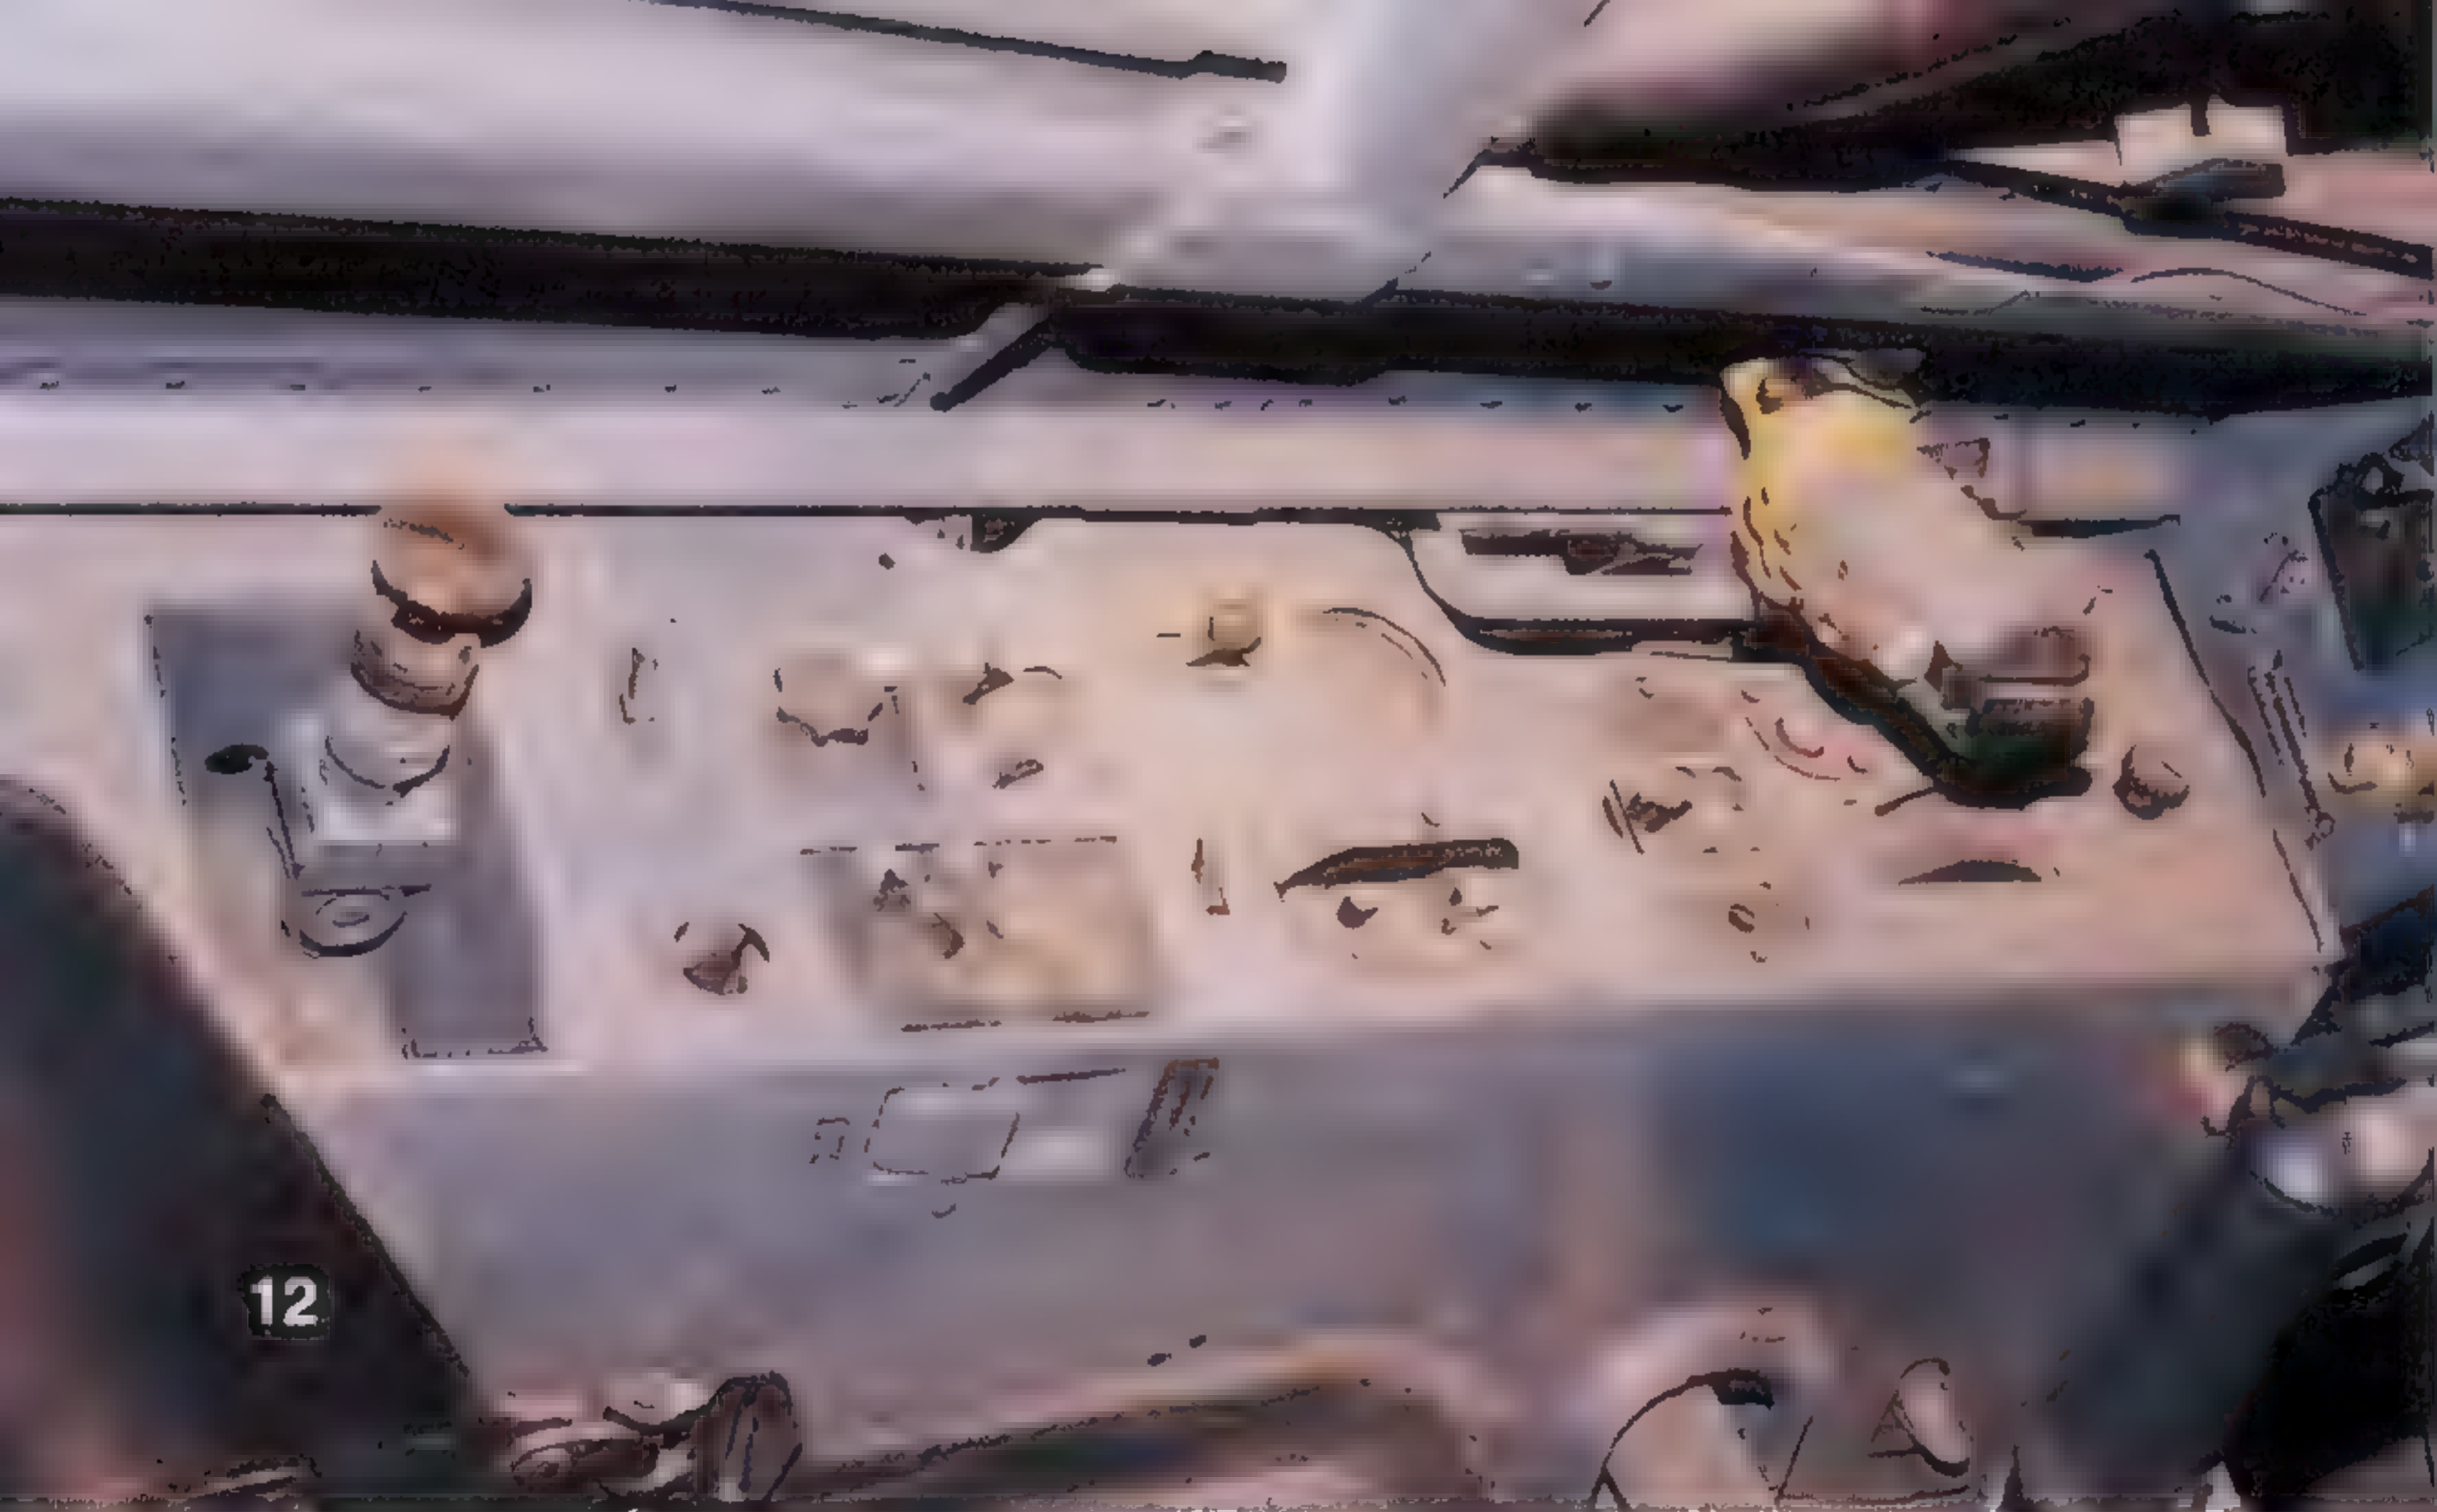
The throttle lever is mounted in the forward section of the port cockpit console. Immediately behind the throttle are the landing gear and flap actuator controls, followed by the horizontal stabilizer trim and radio switches. The friction knob for the throttle lever is extending from the bottom of the console beneath the throttle. (Molnar & Hugo)

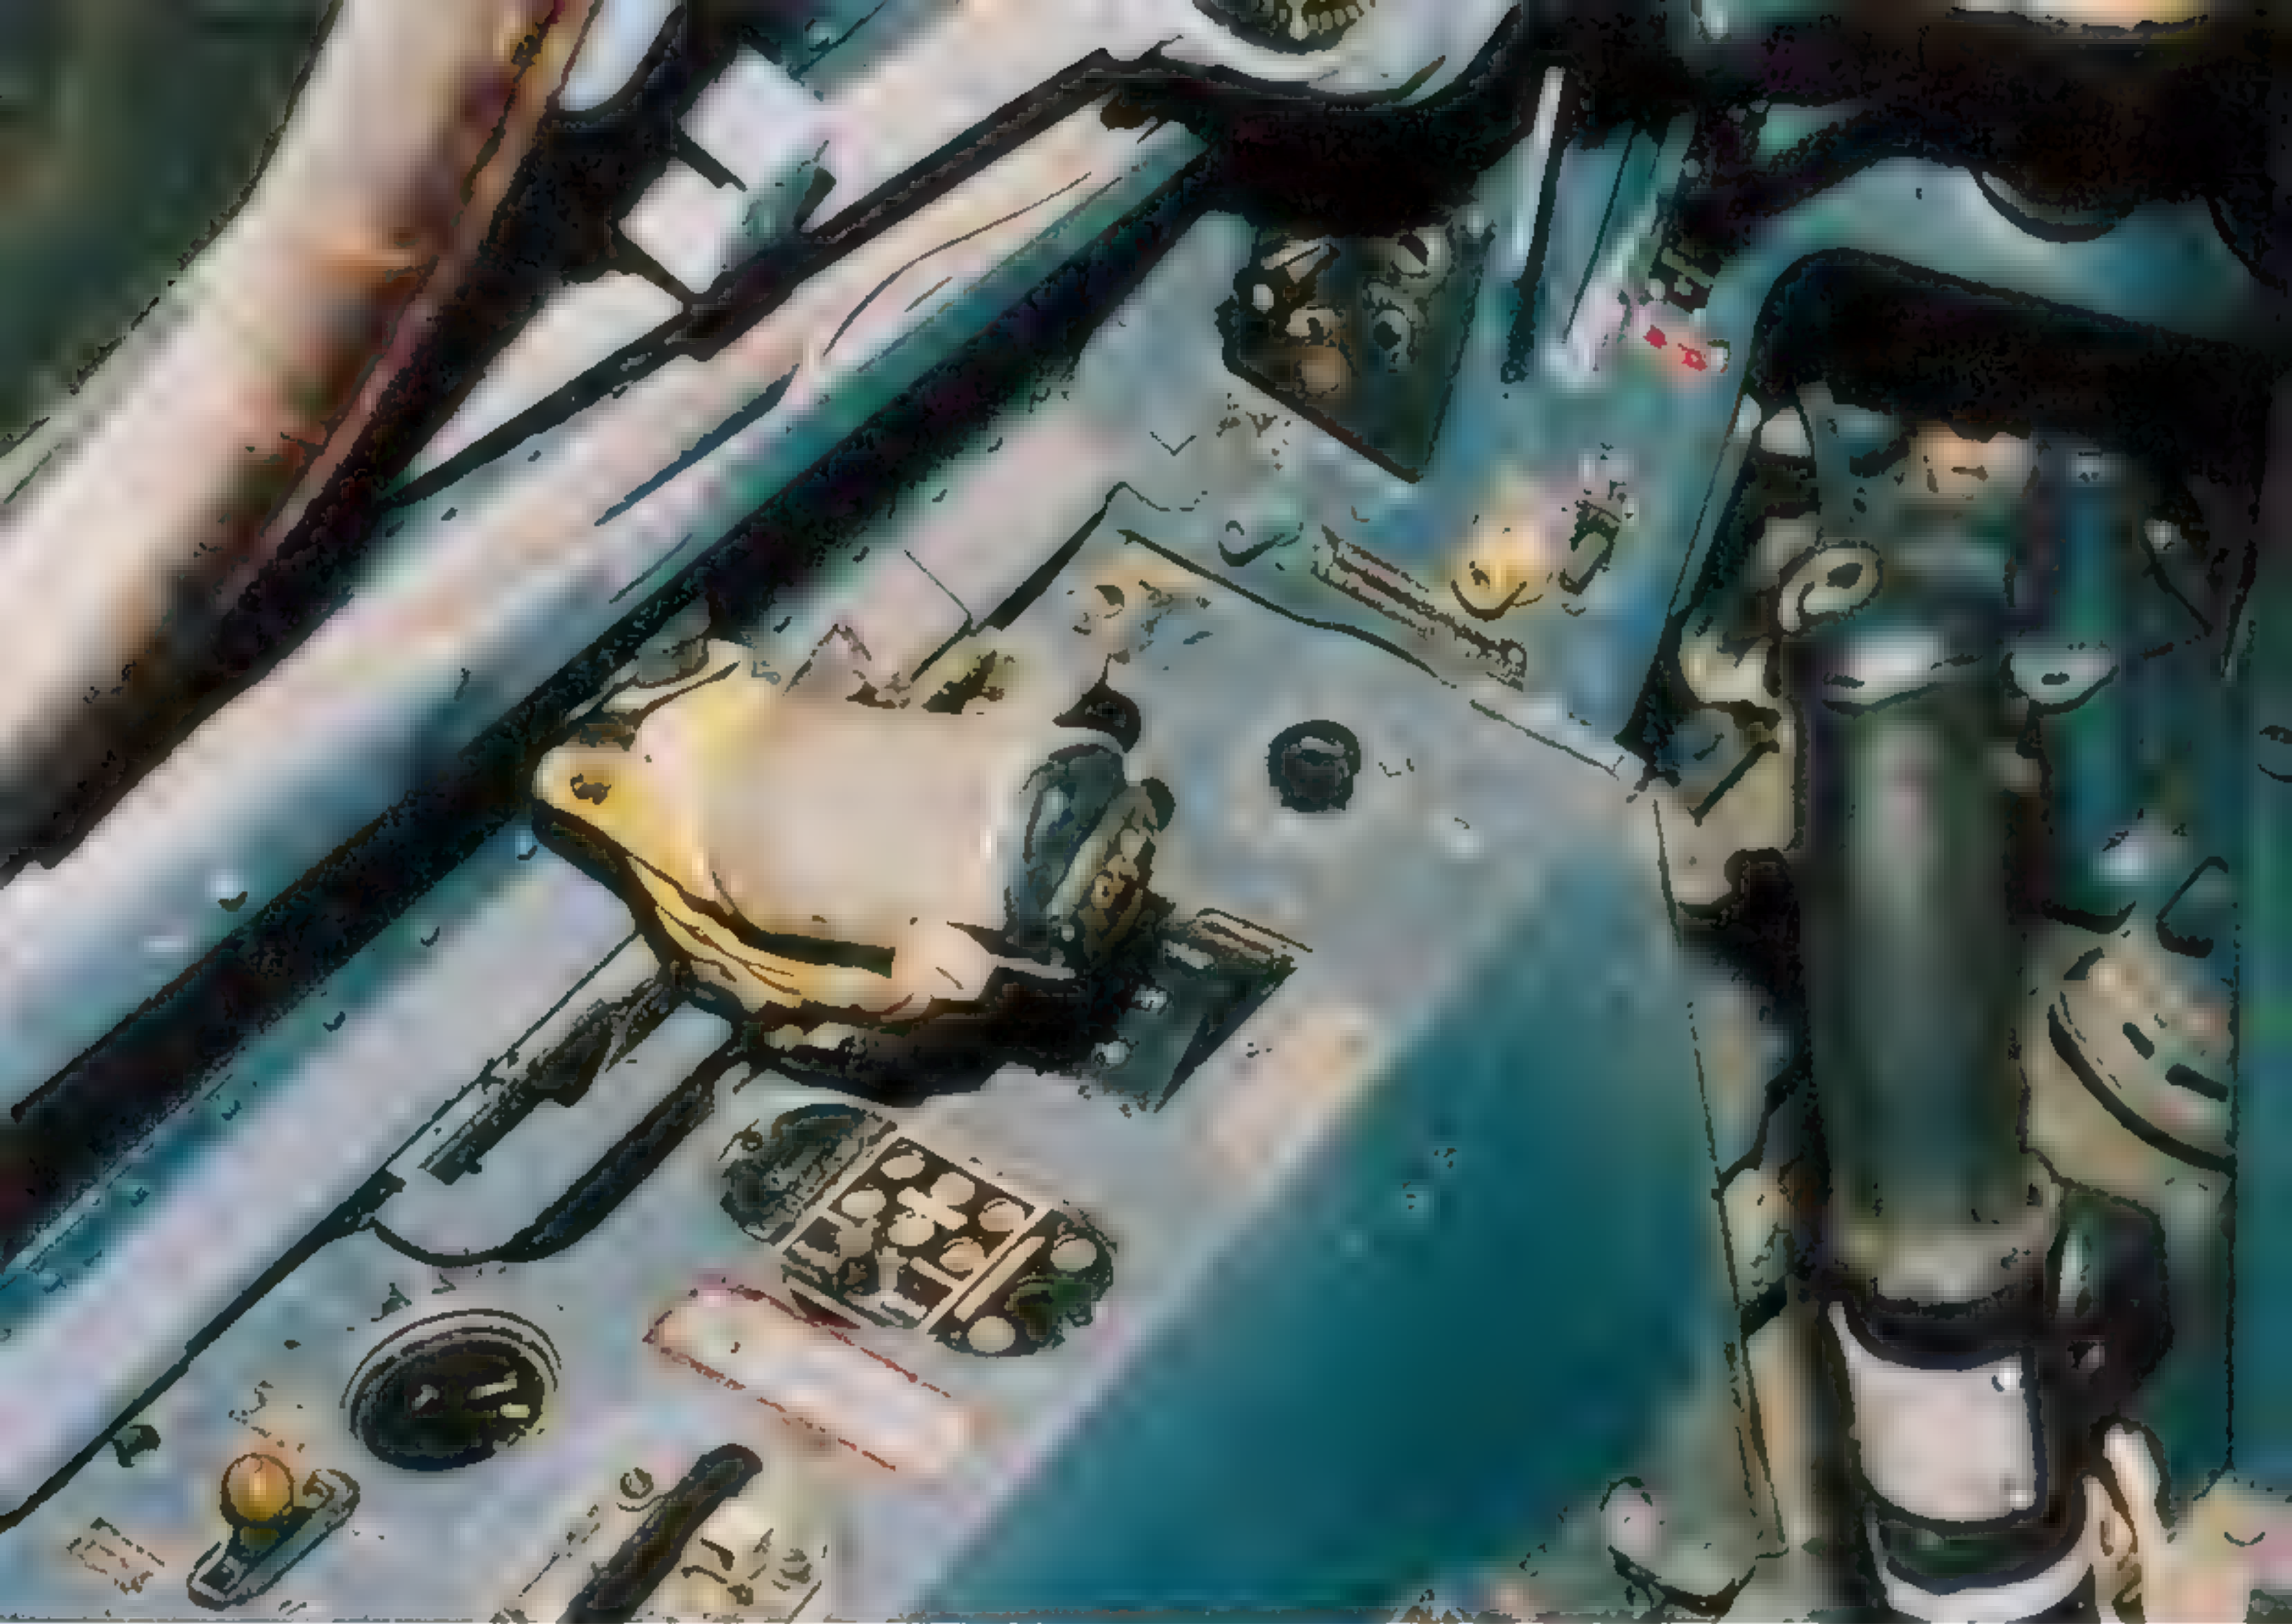
The cockpit side consoles extend to the floor of the cockpit, although they do not extend forward past the instrument panel. The single throttle lever is across from the control stick grip. Almost all instruments and switches are black with red, white, and yellow piping. The A-6 port side console is little different from those on earlier model Fw 190s. (Molnar & Hugo)

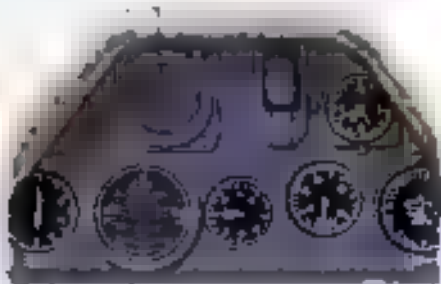
# FuG 217 Radar Scope

Exact placement of other instruments was slightly altered among Fw 190A variants.

The scope for the FuG 217 radar was removed from the Fw 190A-6's upper instrument panel. Ammunition counters were located in this space on other Fw 190s. The area to the right of the radarscope normally housed the Revi 12C/D gunsight used for the Fw 190A-1 through A-6, which was still needed for night operations. The padding around the instrument panel glare shield is the original leather. American cockpit instruments were installed in place of the original German instruments during restoration. (Molnar & Hugo)

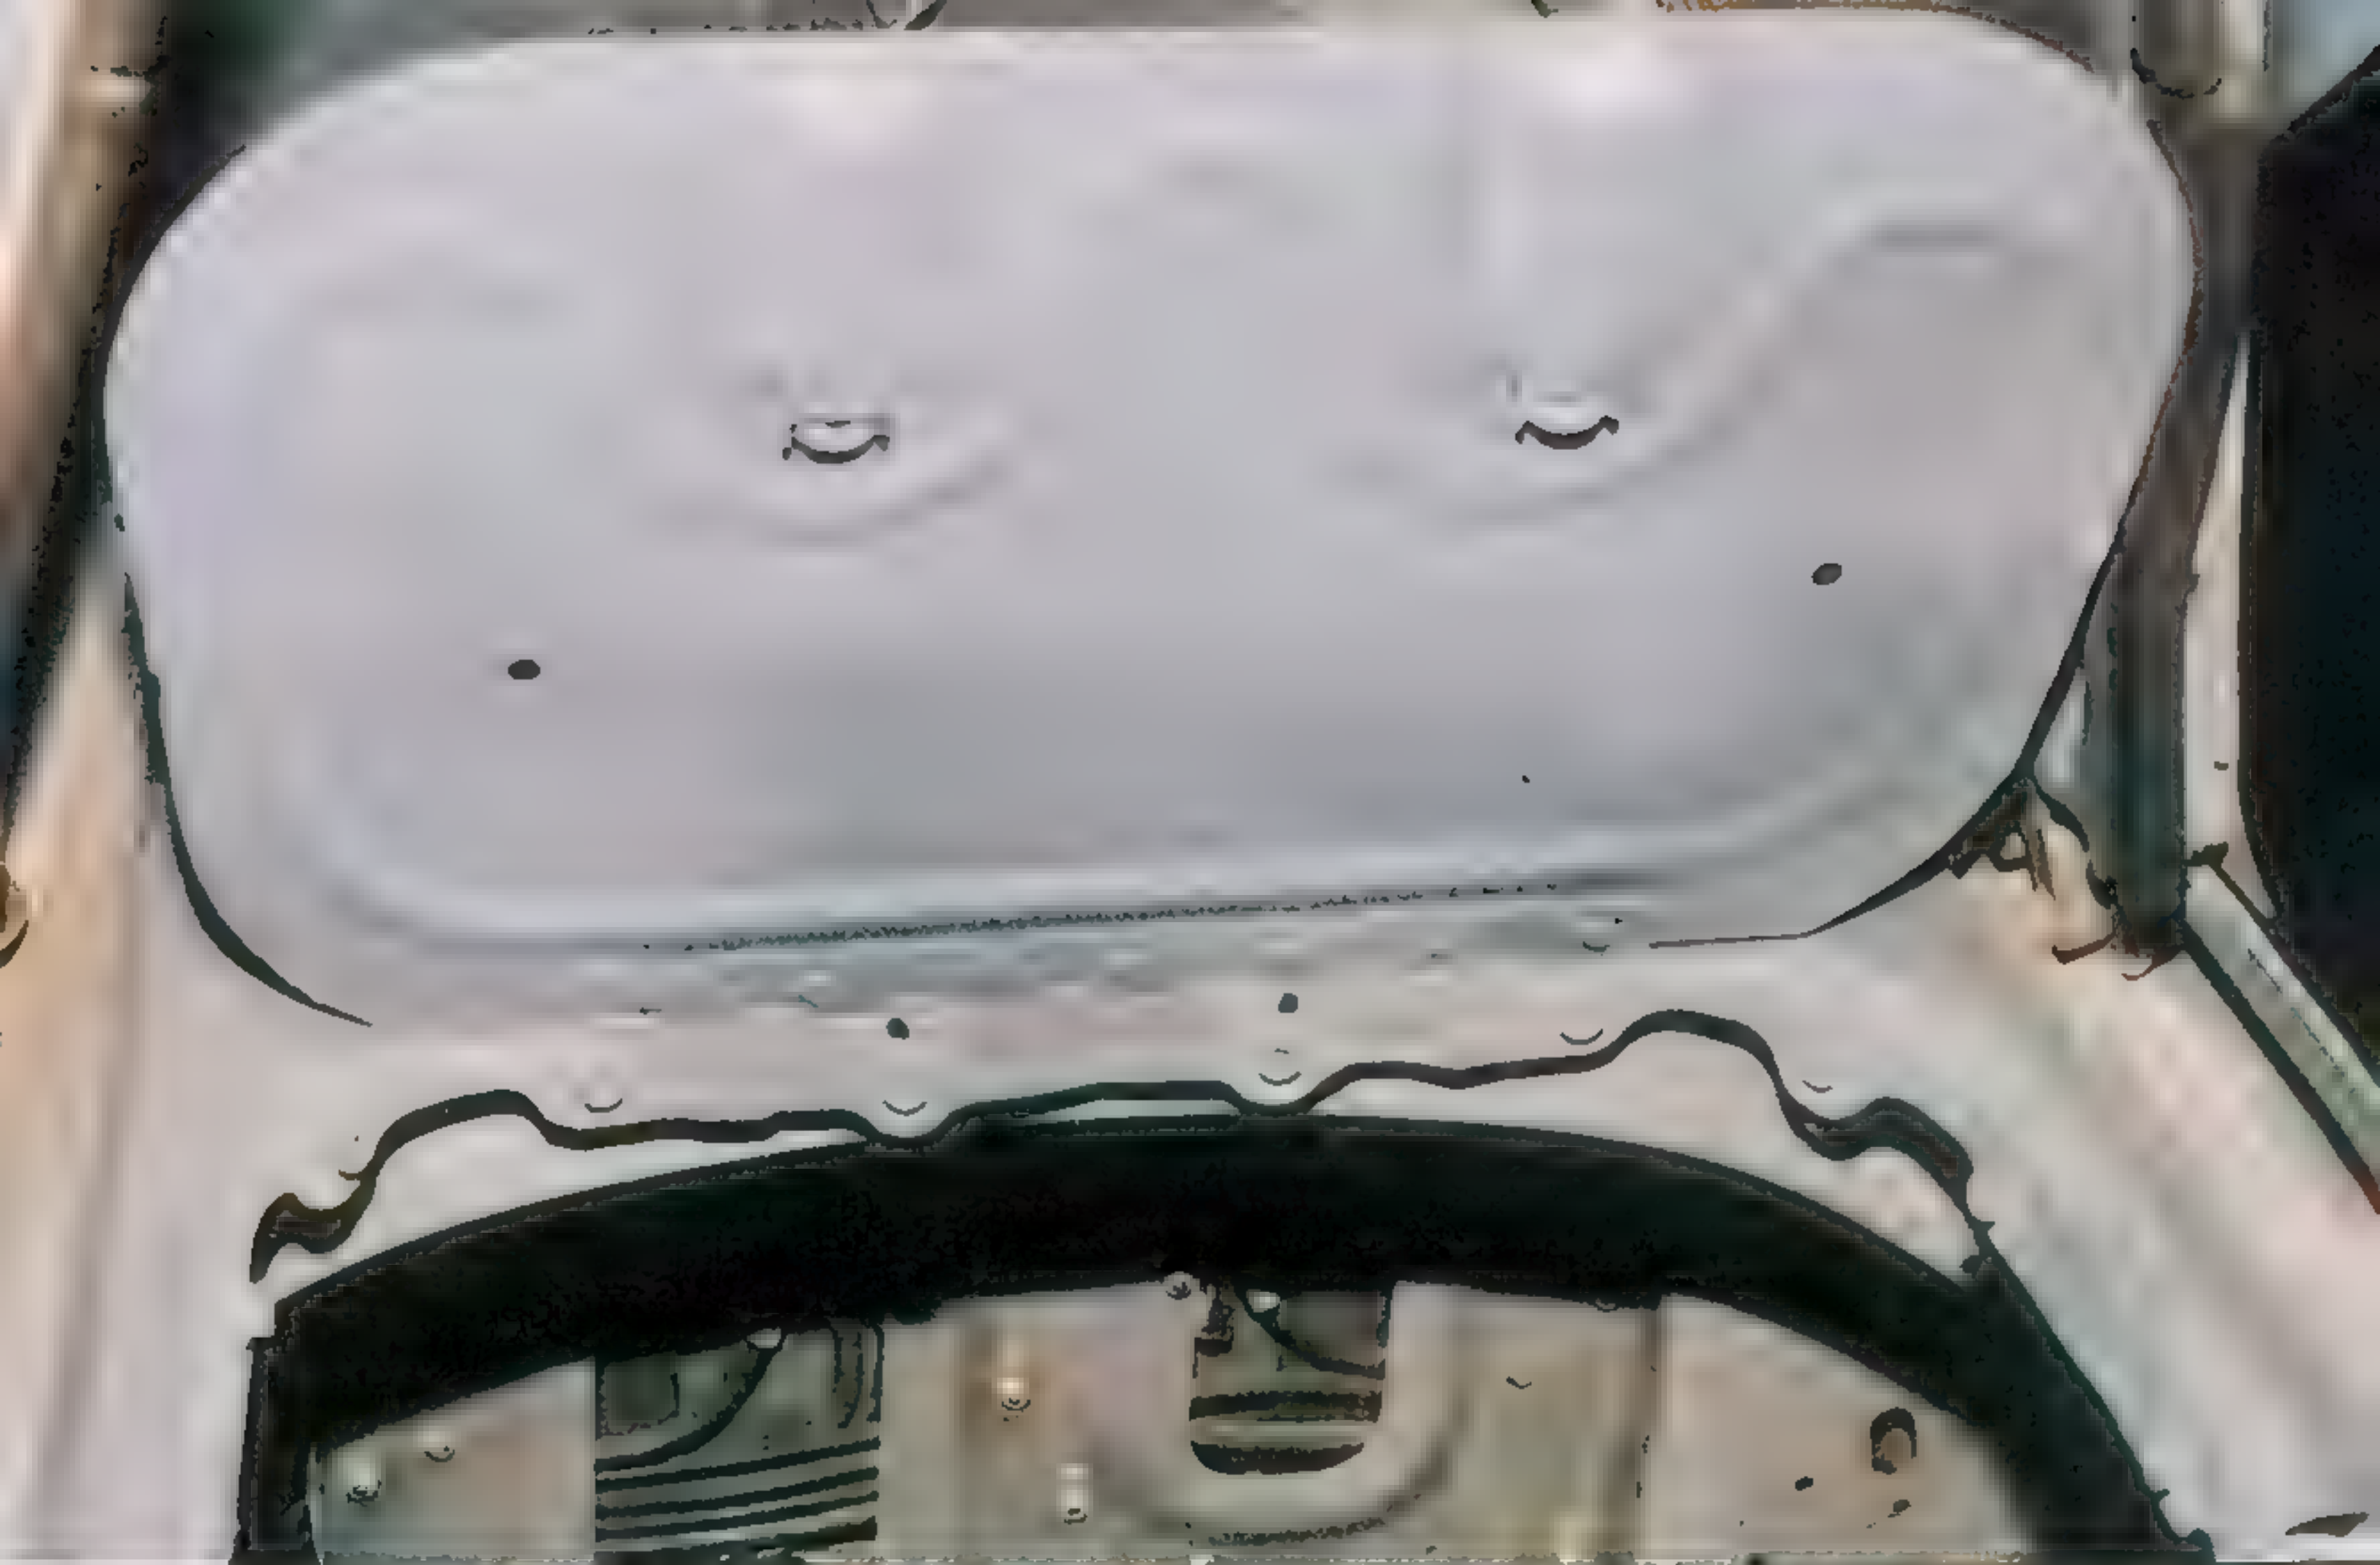
The baggage compartment aft of the pilot's seat was used to store various items according to the mission or movement of the pilot or aircraft. Radios in early Fw 190 models were mounted aft of this compartment. Later Fw 190s used this storage space to house the radios while either an 18.7 gal (70.8 L) GM-1 nitrous-oxide power boost tank or an additional 30.4 gal (115 L) fuel tank was placed aft of this compartment. (Molnar & Hugo)

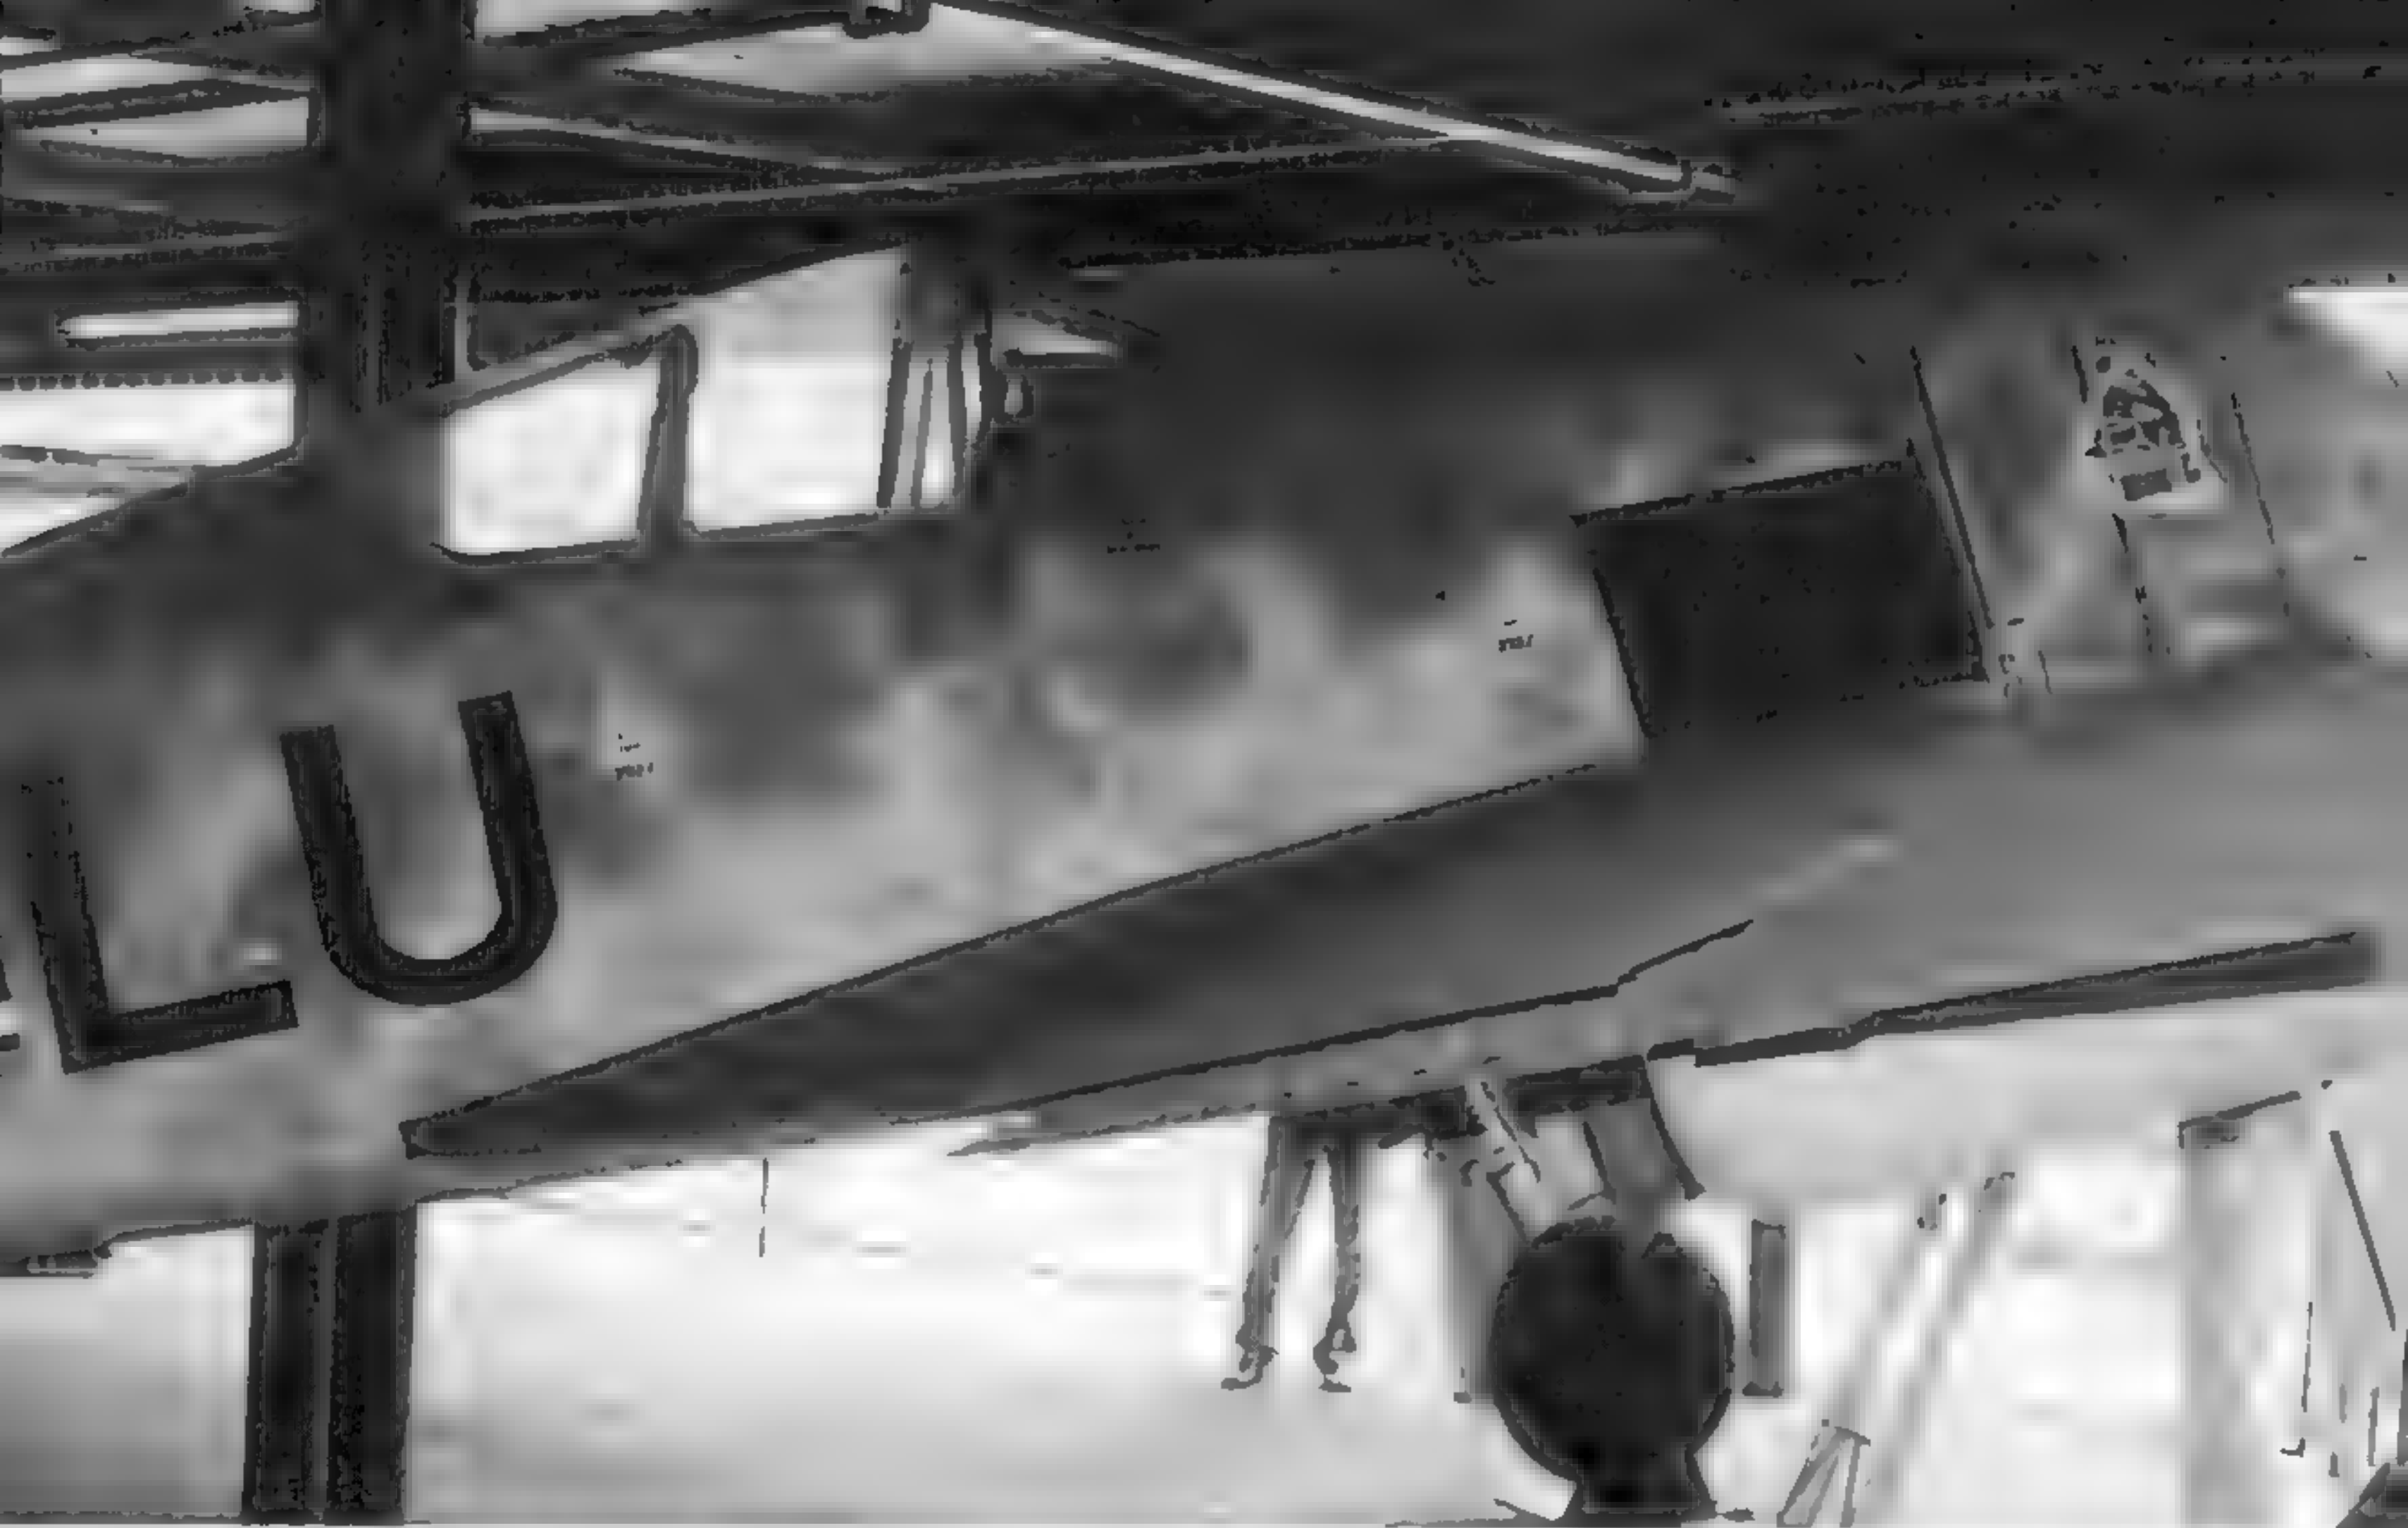
The Fw 190A-6 flaps are deployed in the 20° down position. The flaps were electrically actuated by a drive motor push rod connected to the flaps' central attachment fitting. The flaps' take-off position was 13° (+/-2°), while the landing position was 58° (+/-3°). (Molnar & Hugo)
